SPECIFIC DEFECT INSPECTION REPORT

Date & Time of Inspection -26th Sep 2014 @ 11:00 am

Address of Inspection -5/30 Smith St, Clayton, VIC

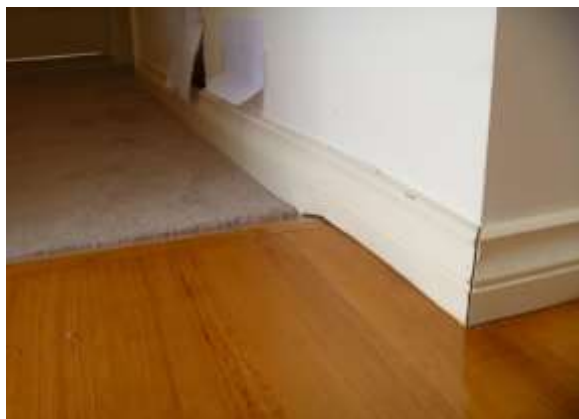
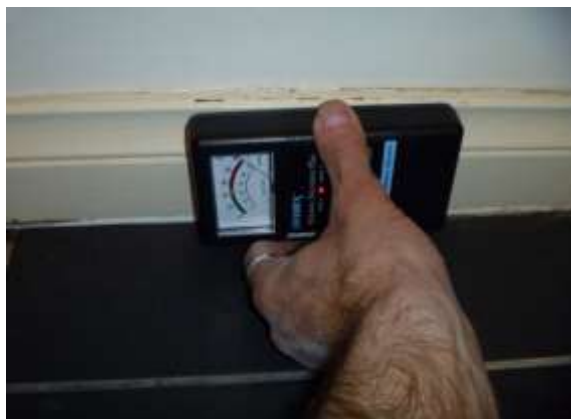
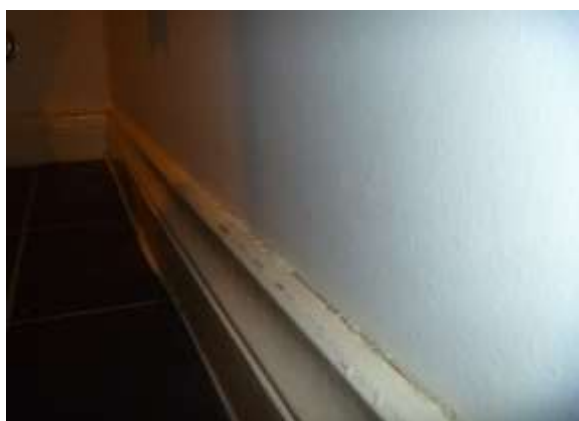
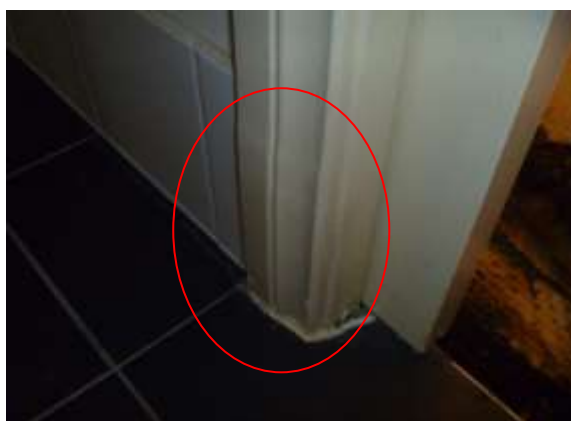
1.1

Inspection Area: Main Building
Location: Interior
Finding: Swollen Skirting Boards & Architrave

Information: The skirting boards on the rear of the shower and next to the toilet were significantly swollen. Also the architrave on the cavity slider was swollen to around 200mm off the tiles. A moisture meter was used to check moisture content of the mdf mouldings with a very high reading to all areas including the lower plaster board. The floor boards behind the shower are also water stained.

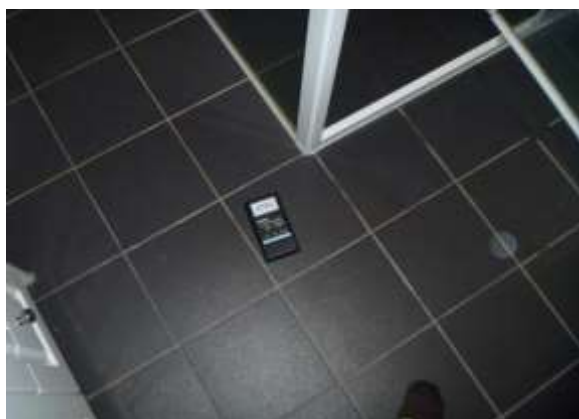
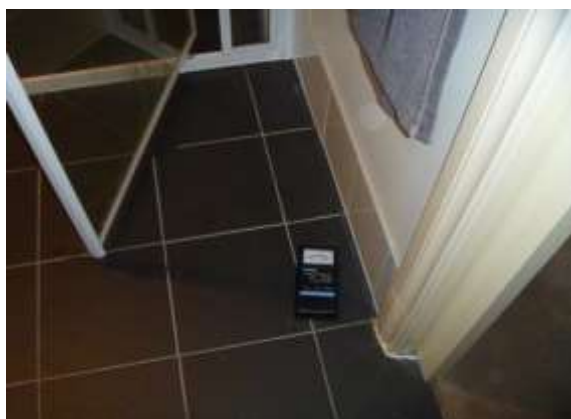
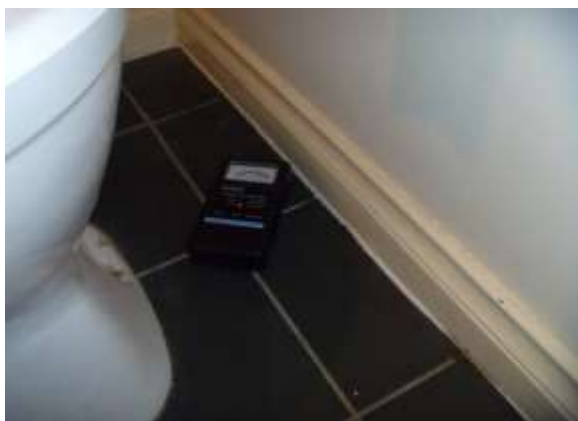
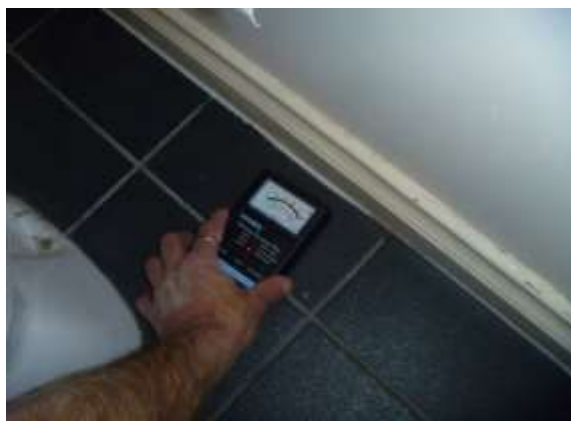
1.2

Inspection Area: Main Building
Location: Interior
Finding: Floor Tiles - High Moisture

Information: A moisture meter was used to check all areas of the bathroom floor tiles. The majority of the floor area showed high readings indicating that moisture from the shower area is seeping across the underside of the tiles. Over time the tile adhesive will loosen causing movement and subsequent cracking and drummy tiles.

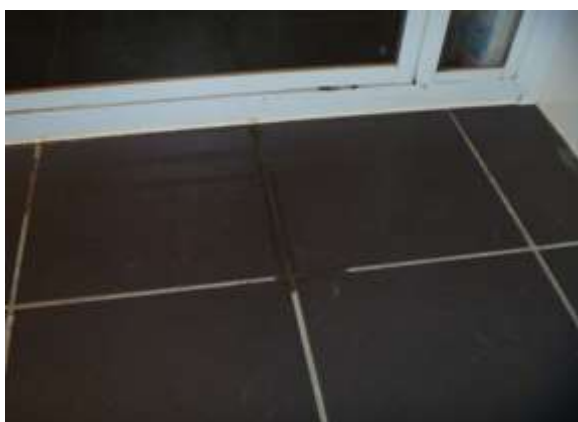
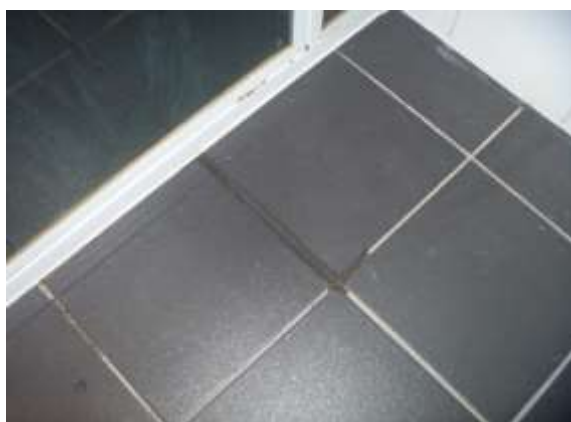
**1.3**

Inspection Area: Main Building
Location: Interior
Finding: Water Seepage - Shower Screen

Information: Water seepage from the shower screen was observed. The client explained that this has always happened. This is either to do with the major moisture defect or seepage from the shower screen.

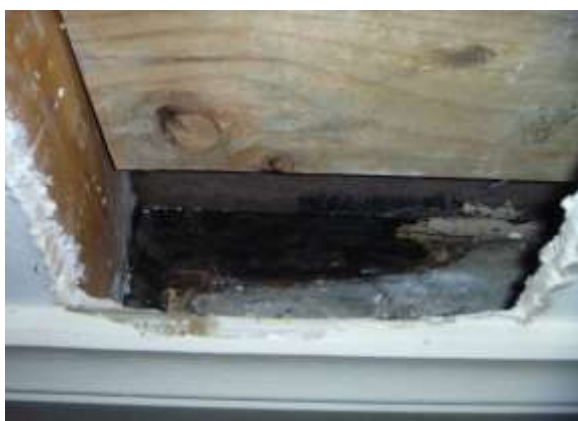
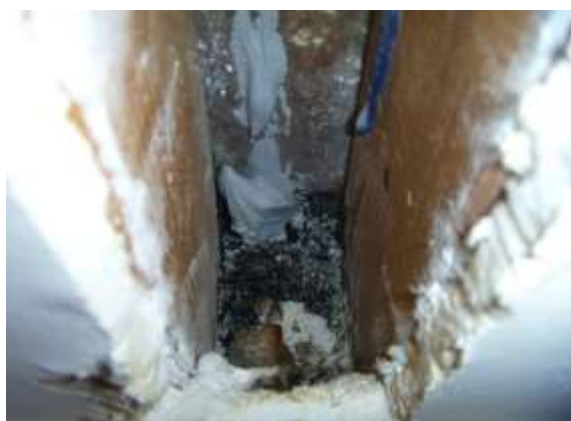
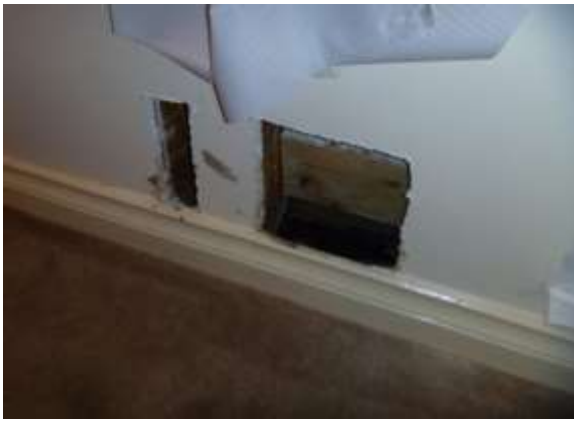
**1.4**

Inspection Area: Main Building
Location: Interior
Finding: Wall Plates

Information: Existing holes to the plaster linings at the rear of the shower were inspected. The wall plate showed significant moisture damage and mould starting to develop. This indicates a constant presence of water on the timber member.

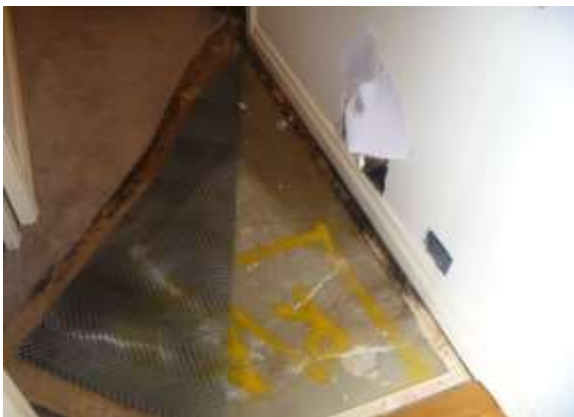
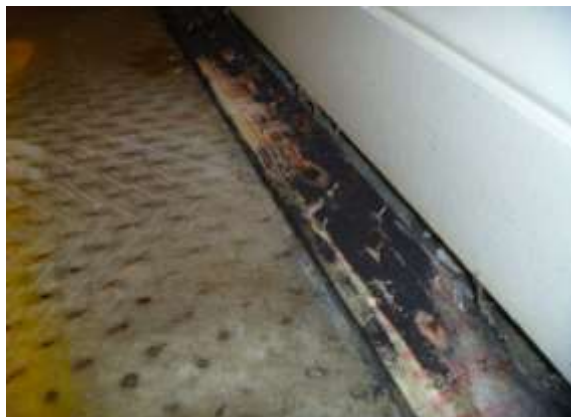
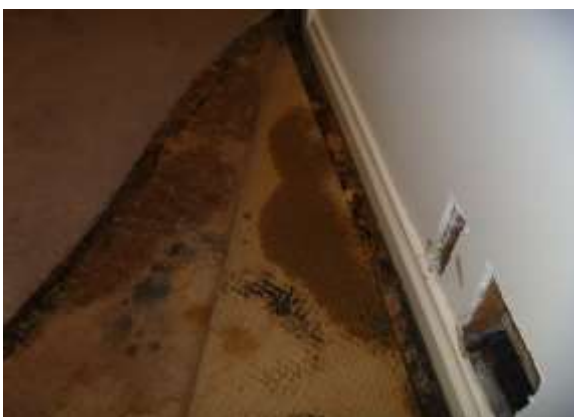
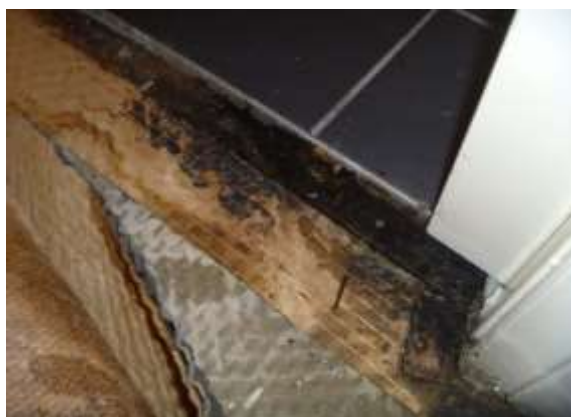
1.6
Inspection Area: Main Building
Location: Interior
Finding: Carpet Lifted

Information: To further investigate, the carpet in the hallway behind the shower was lifted to check the underside for moisture evidence or damage. Significant damage was observed to the underside of the carpet and smooth edge timber material. High moisture was clearly visible on the concrete slab and carpet underlay. Mould was developing and rot was forming on the smooth edge. It is the opinion of the consultant that the moisture is coming up from under the slab and could be from a cracked or poorly sealed plumbing connection in the shower waste under the slab.

This defect is of major significance and requires immediate rectification to avoid further deterioration, mould growth and structural damage and can reasonably be considered the responsibility of the builder.

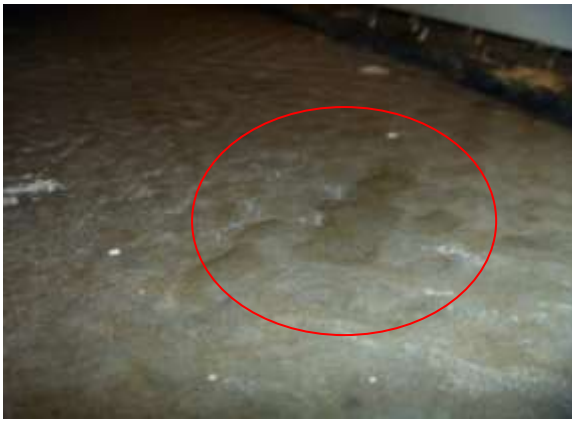
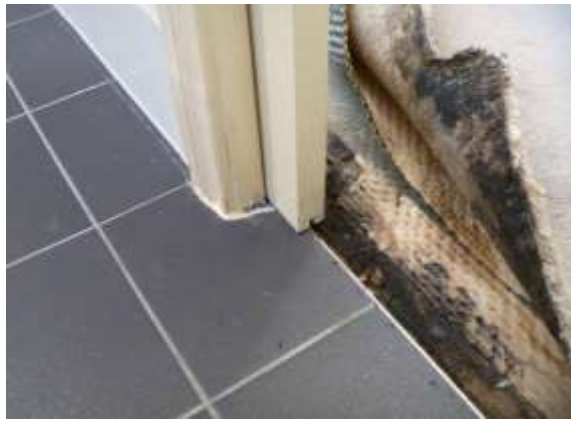
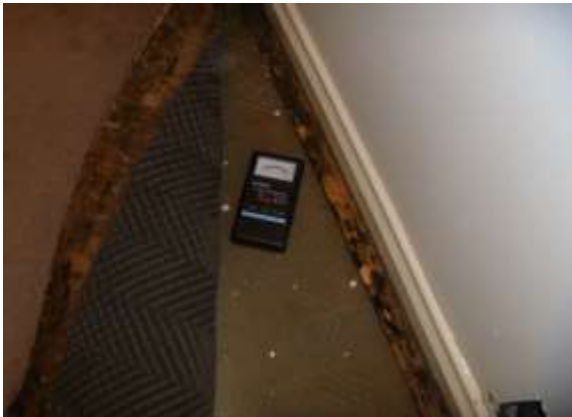
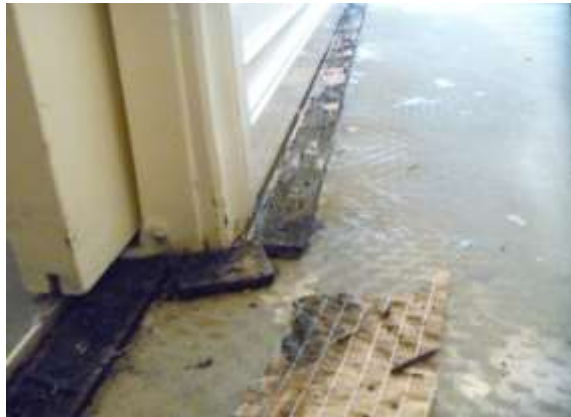
1.7
Inspection Area: Main Building
Location: Interior
Finding: Additional Photos Under Carpet

Information: See photos. Photo 1 even shows a small amount of water ponding.

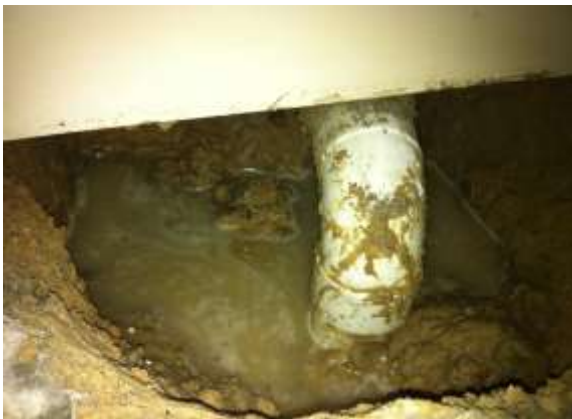
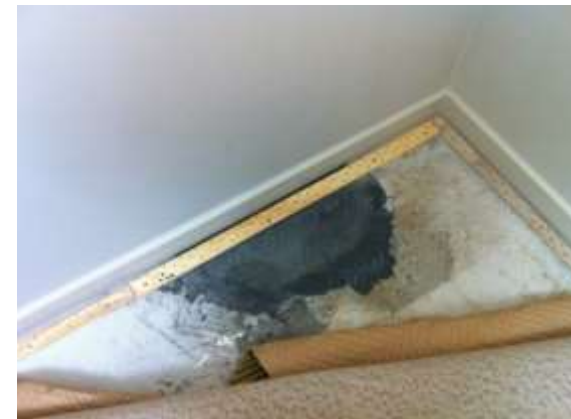
1.8

Inspection Area: Not Applicable
Location: Not Applicable
Finding: Attached Photos for Example Only

Information: These photos are NOT taken from 5/30 Smith St, but are from another job BIA inspected. These photos are a smaller scale example of what may be happening. The shower waste in these example pictures was not installed correctly causing flooding of the shower waste rebate and subsequent damage to the slab and carpet from rising damp. Note: this is only the opinion of the consultant and further investigation will be required to fully determine the cause at 5/30 Smith St, Clayton.

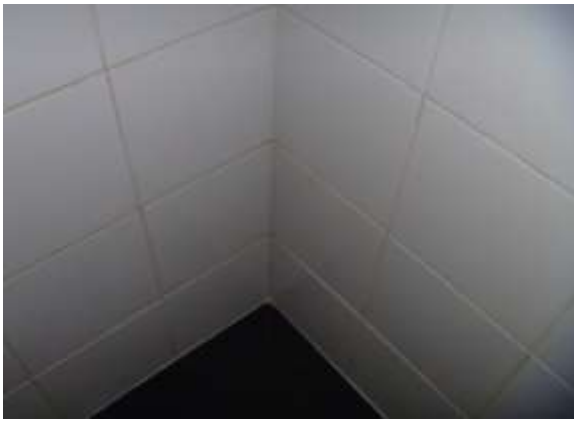
1.9

Inspection Area: Main Building
Location: Interior
Finding: Silicone OK

Information: The silicone in the corners of the shower and along the edge of the shower frame appeared adequate at the time of inspection. Leaking from this area is unlikely.
