PRE-PURCHASE BUILDING & TIMBER PEST REPORT

Date & Time of Inspection - 5th Oct 2014 @ : 10:30am

Address of Inspection – 15 Smith St, Smithton Hill, VIC

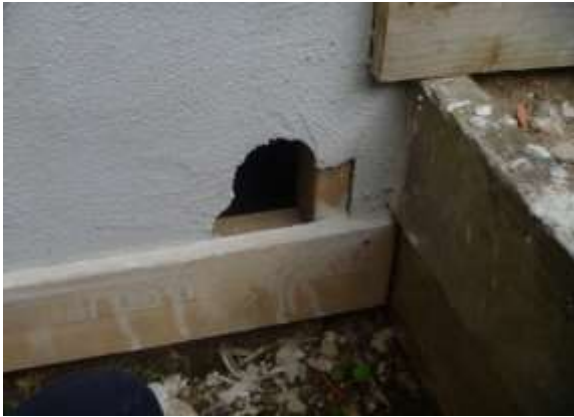
There was no access to inspect under the centre of the building. A small inspection hole was noted to the rear wall near the deck. No other area was inspected and no report was carried out in this area. Note: the client should be aware that hidden findings may be present in areas that cannot be inspected.

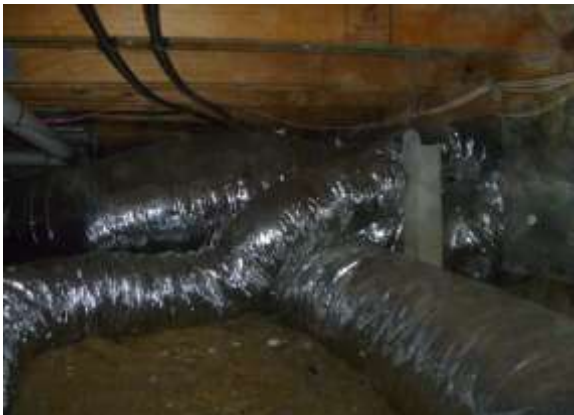
Areas of the subfloor at the LHS of the building and centre could not be reached due to excessive ductwork and plumbing blocking the way. Ductwork and plumbing can be damaged and squashed if climbed upon so the inspector did not enter the area. Ductwork and plumbing would have to be removed to accommodate a complete inspection of the area. This is implacable but we do recommended it.

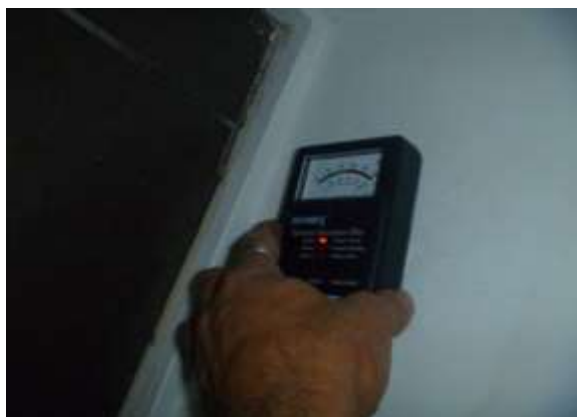
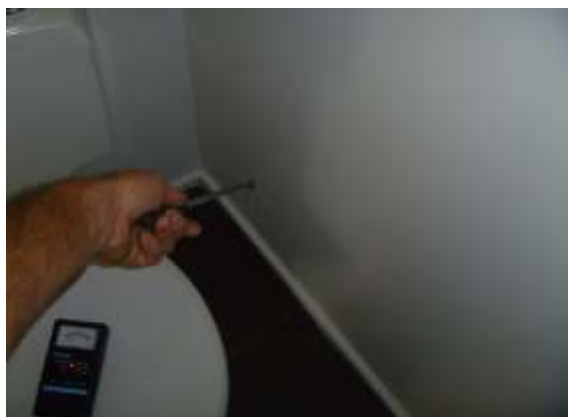
Information: A moisture meter was used to test the wall area with a positive result indicating a wet / active leak condition. The cause of the moisture is undetermined. Contact a qualified tradesperson for further assessment.

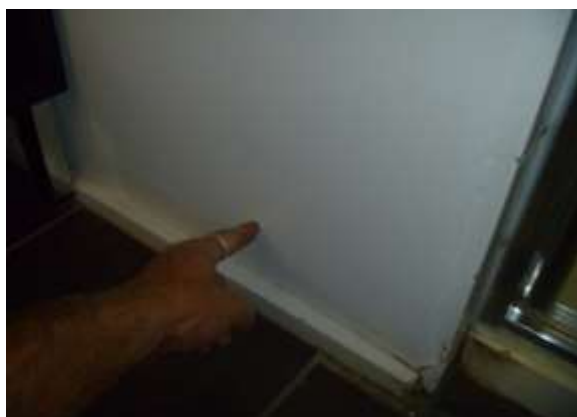
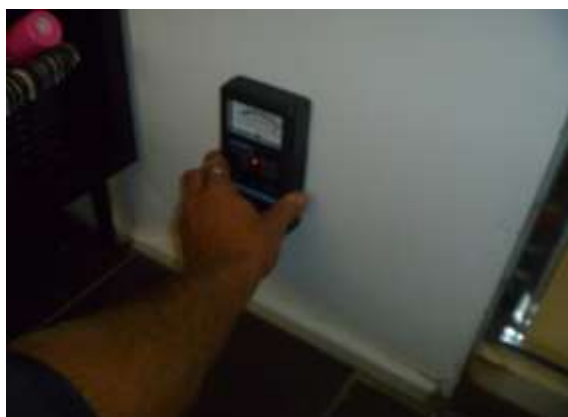
1.4.2

Information: A moisture meter was used to test the wall area with a positive result indicating a wet / active leak condition. The cause of the moisture is undetermined. Contact a qualified tradesperson for further assessment. Note: it appears this area has been freshly painted.

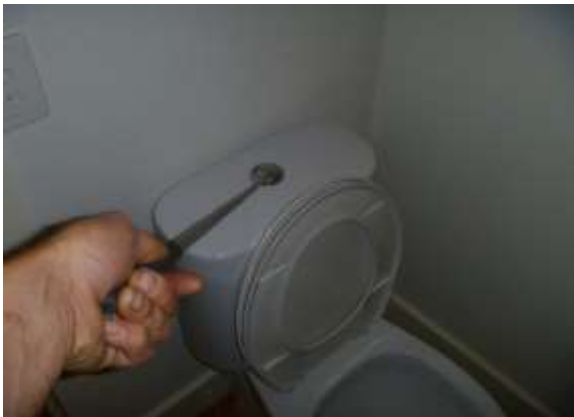
Information: The toilet would not flush at the time of inspection. This may indicate a plumbing fault. Consult a licensed plumber for further investigation.

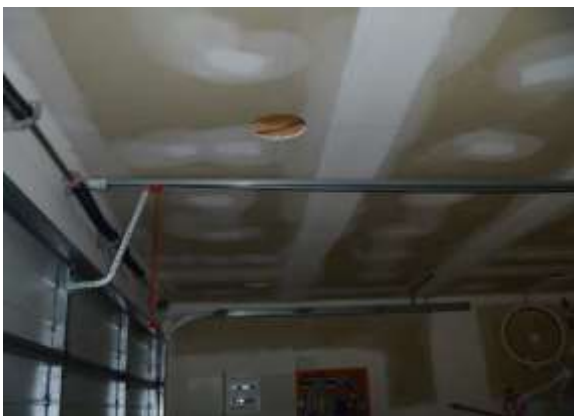
1.5.5

Information: Finishings around this area indicate below standard workmanship and unprofessional finishing. This is not a significant defect, however does add to the overall assessment of the buildings condition. The client may choose to have the defects fixed at their discretion. Lights have not been fitted and walls are not finished.

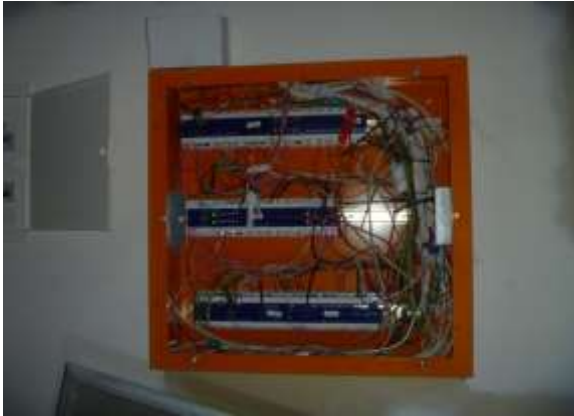
1.5.6

Information: Switchboard is considered untidy. Recommended the client engage an independent licensed electrician for further inspection of the house's electrical system.

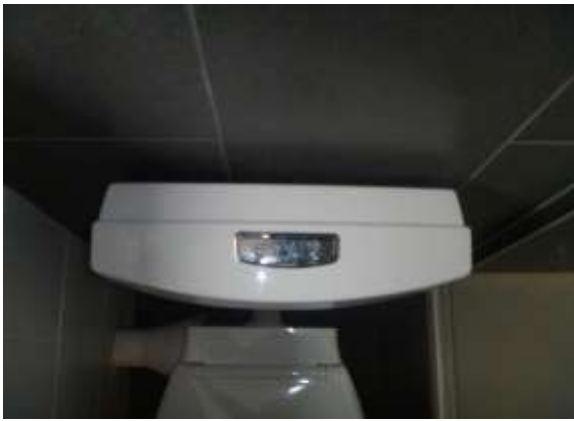
Information: The toilet cistern has not been attached to the wall. The toilet still works, however this is not the correct installation method.

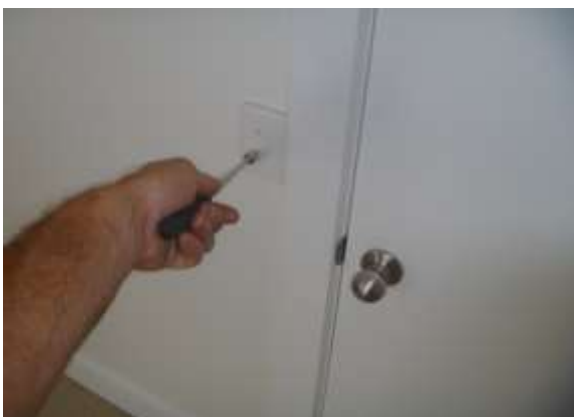
- 1.5.14**
Inspection Area: Main Building
Location: Bedroom > Centre Right
Finding: Light Switch - Not working
Information: The bottom switch in this room has no function. Not sure if it was meant for anywhere in particular. Further investigation is required.

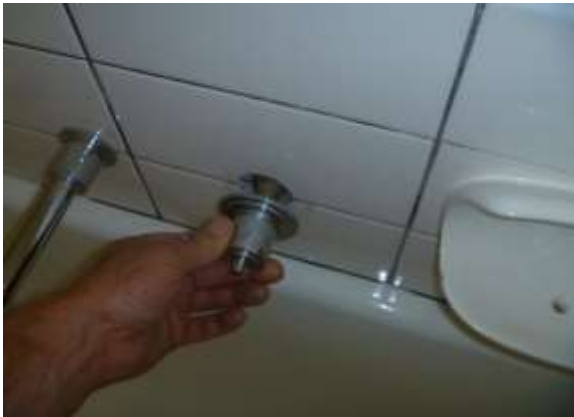
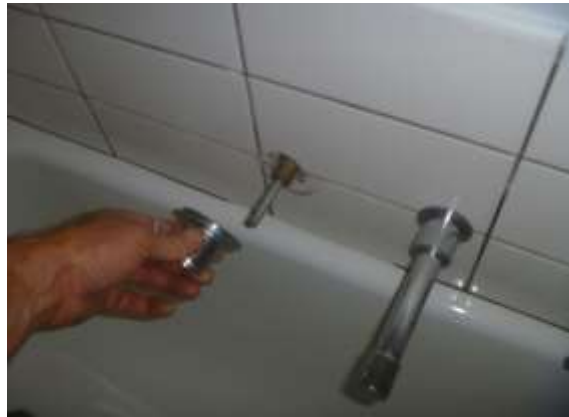
1.5.16
Inspection Area: Main Building
Location: Bathroom
Finding: Taps - Detached
Information: The taps came away from its position when operated. Maintenance by a licensed plumber is recommended.

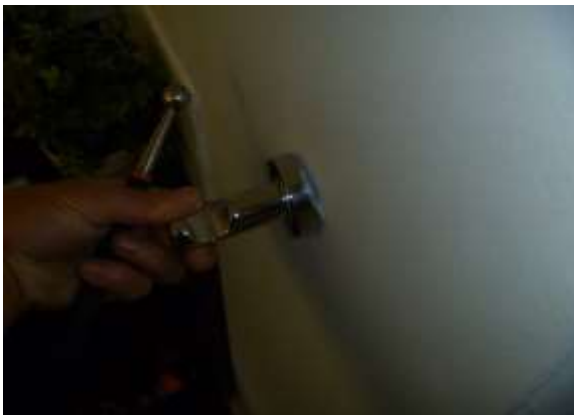
1.5.17
Inspection Area: Main Building
Location: Bathroom
Finding: Towel Hook - Detached
Information: The towel hook has become detached for its intended position. Maintenance is required.

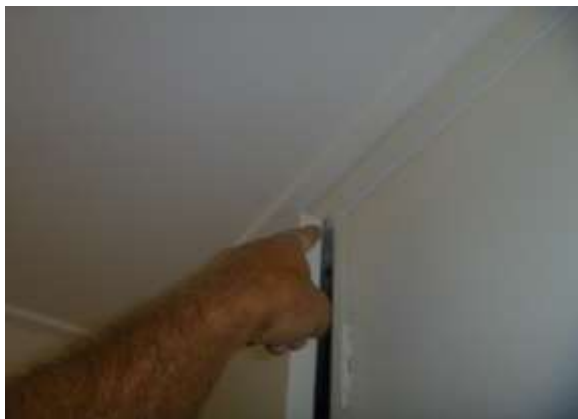
1.5.18
Inspection Area: Main Building
Location: Bedroom > Rear Left
Finding: Doors - Maintenance Required
Information: Doors throughout the house require general maintenance. Uneven floor levels and/or door hardware in the form of hinges, locks, handles etc. can come loose overtime, which can affect the operational performance of the doors, causing them to rub, jam or not close completely. Consult a carpenter or general contractor for maintenance at the client's discretion.

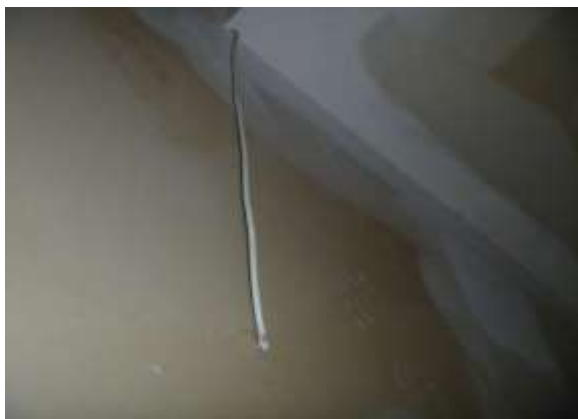
**1.5.19****Inspection Area:** Main Building**Location:** Garage**Finding:** Cable Not Connected**Information:** See photo for example. Contact an electrician for work required.

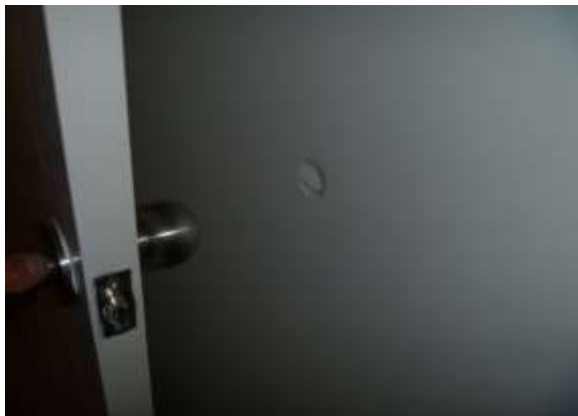
**1.5.20****Inspection Area:** Main Building**Location:** Master Bedroom**Finding:** Walls - Impact Damaged**Information:** Impact damage was observed to the walls in this area. Consult a professional plasterer or general contractor for remedial works.

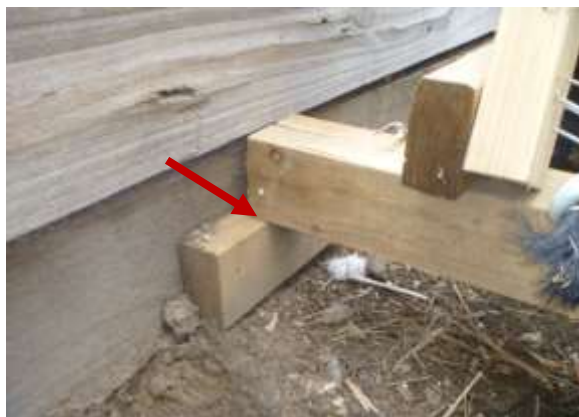
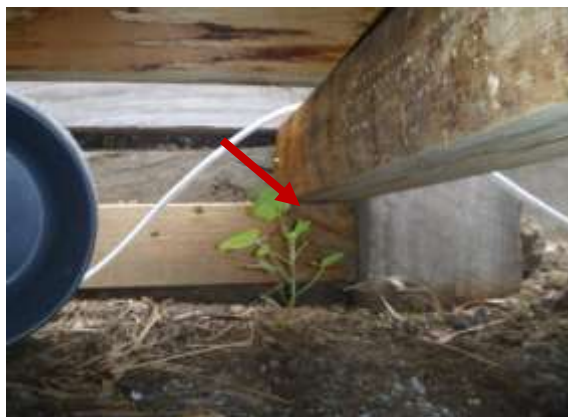
Information: Minimal support was observed to the floor frame members. Sagging and/or bouncing in the floor area is likely if left as is. Today's construction methods would require individual stump supports to all bearers. At the moment the bearers are supported by blocks of timber nailed onto rotting retaining walls. Contact a qualified carpenter for additional support.

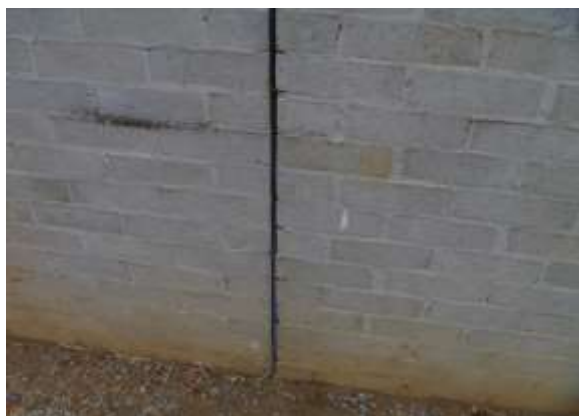
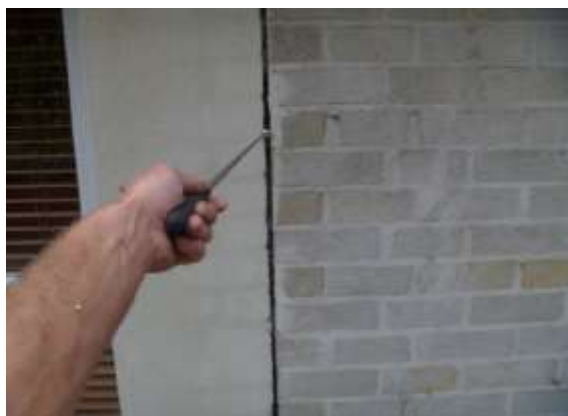
Information: The expansion joint in this area was not covered by an adequate weather proof sealant. Not urgent, however should be applied to eliminate the chance of moisture ingress to the frame. A general contractor could be hired for this work.

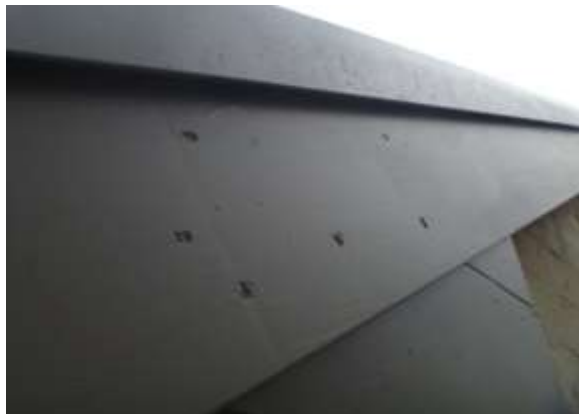
2.5.2

Information: Nails to the exterior cladding have not been properly finished. Nails should be punched under the surface of the cladding and filled with exterior filler, then sanded and painted. Contact a general contractor or professional painter for further works required.

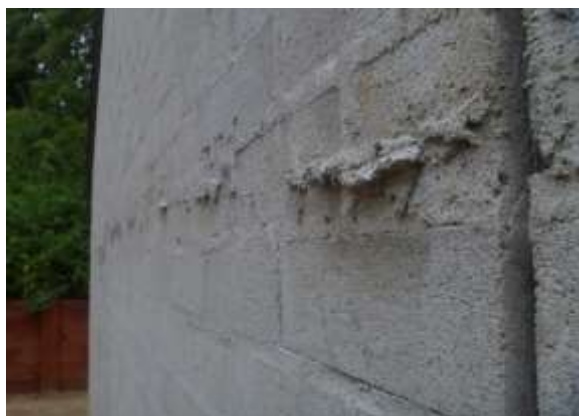
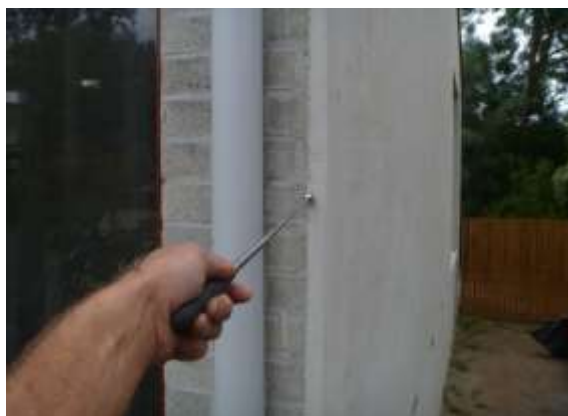
2.5.3

Information: Render finishing has not been completed to the front and LHS exterior walls. Can be completed at the client's discretion.

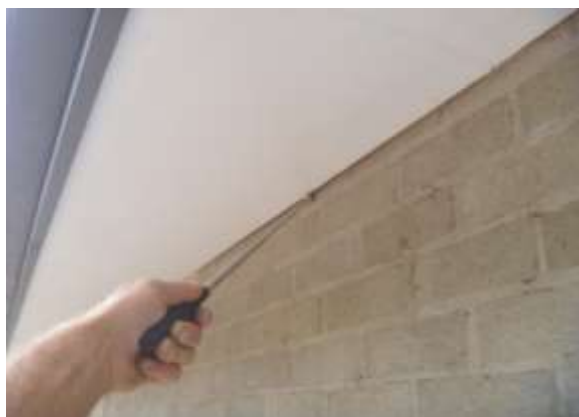
2.5.4

Information: The beading for the eave sheets has not been installed along the brickwork. Can be completed at the client's discretion.

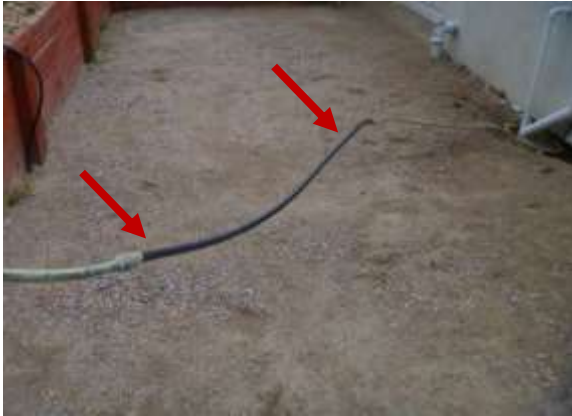
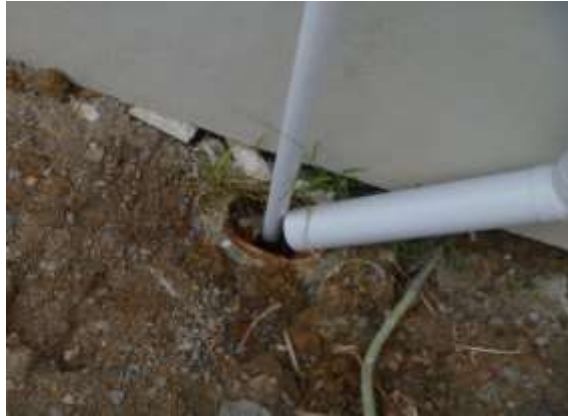
2.5.5

Information: The plumbing in this area requires further investigation by a licensed plumber. Pipes were hanging loose across the LHS yard and the grey waste was not sealed. See photos for example.

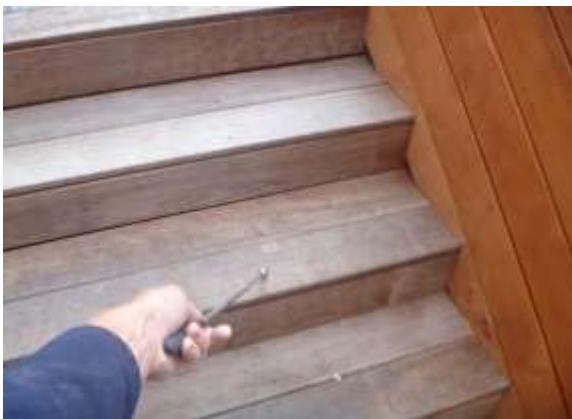
**2.5.6**

Information: Fixing to this building element were inadequate. Stair treads were loose. Contact a carpenter for further work.

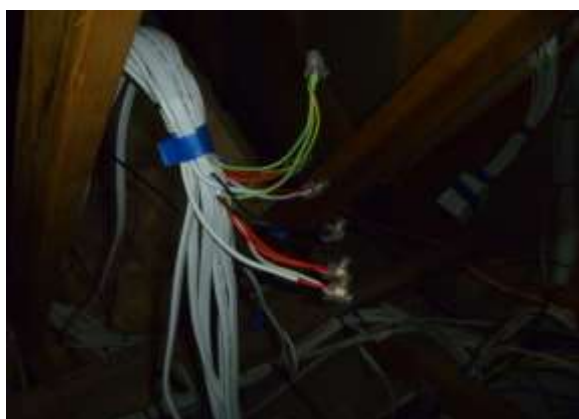
Information: Electrical cable joins are inadequate. This should have been adequately secured and boxed off to make the cables double insulated to prevent personal injury. Contact licensed electrician for repairs. Note: we are not electricians and always recommend an inspection by a professional with the appropriate licenses and qualifications.

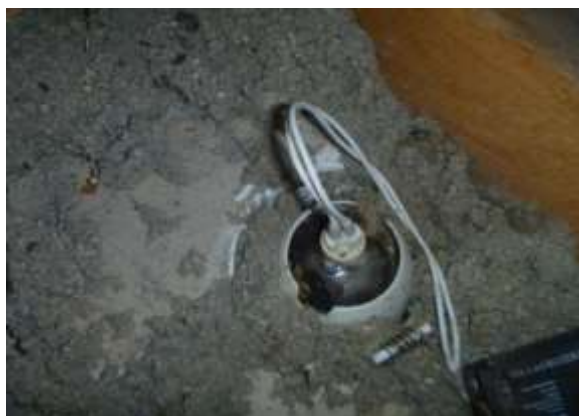
3.2.2

Information: The down light holdings within the ceiling void were found to be missing protective covering during inspection. Whilst in use, halogen down lights create a large amount of heat that, without these protective coverings, has the potential for ignition of any flammable objects that the down light may come into contact with (e.g. insulation, debris etc.). It's recommended the client consider replacing the lights with LED's or have covers installed to help prevent the possibility of fire.

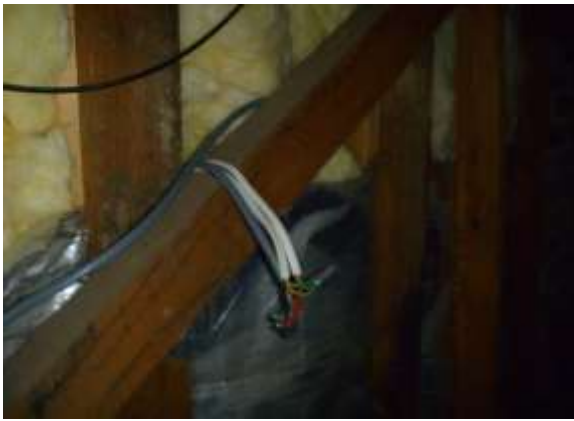
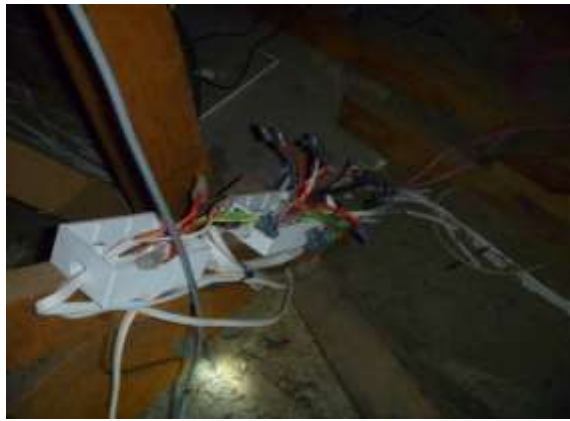
3.2.3

Information: Like the defect found above the kitchen, the electrical cable joins are inadequate. This should have been adequately secured and boxed off to make the cables double insulated to prevent personal injury. Contact licensed electrician for repairs. Note: we are not electricians and always recommend an inspection by a professional with the appropriate licenses and qualifications.

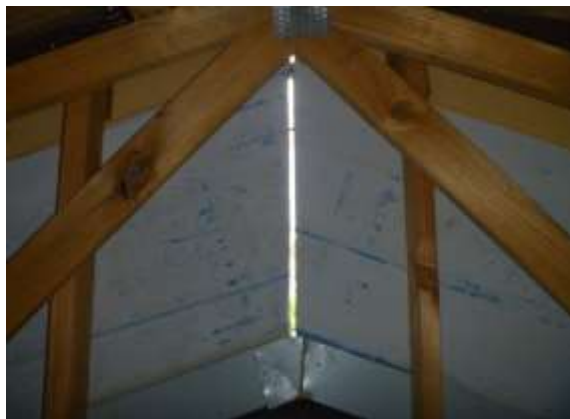
Information: The exterior cladding has not been completed. Obvious gaps were located that will allow water to penetrate the roof space. Further finishing is needed.

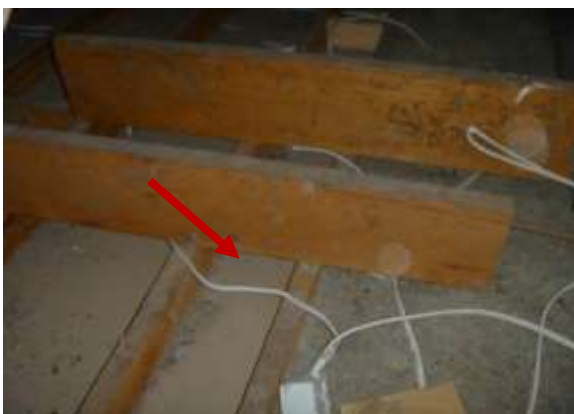
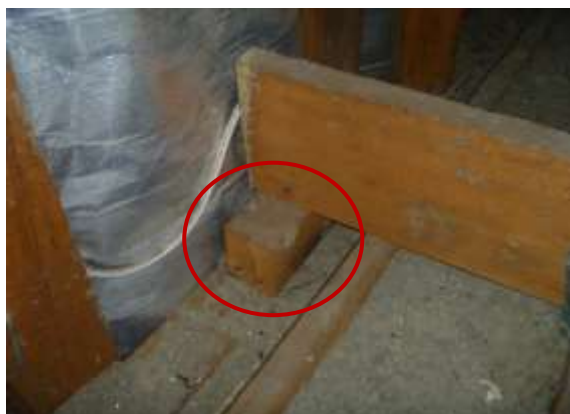
3.4.2

Information: Frame alterations were observed. It is undetermined whether alterations identified will affect the structural integrity of the building because there was no visible evidence of major deviations or damage. The hanging beams that take the load of the ceiling of the lounge and rear bedroom do not appear to have direct load bearing onto the below wall. The load appears to be placed on the ceiling joists either side of the wall. Unless the ceiling joist is directly on top of the wall, further supporting blocks will be required where the red arrow is shown. Wall support could not be determined because the plaster lining was obstructing the top of the wall plate. Photo 1 below shows where the support should be and photo 2 shows an example of how the hanging beam should be supported.

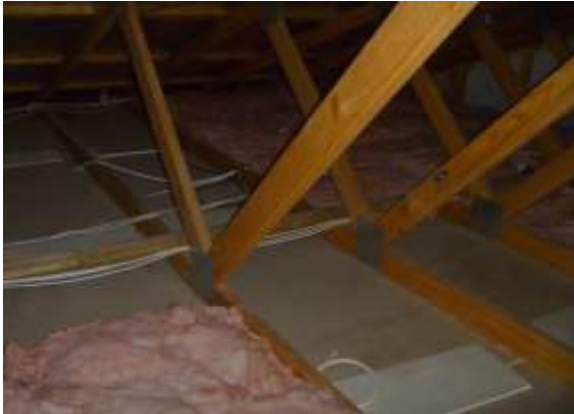
Information: Insulation is missing to this area of the ceiling. The energy efficiency of the house may suffer due to this defect. It's recommended replacing insulation where necessary. A general contractor could be hired for this work.

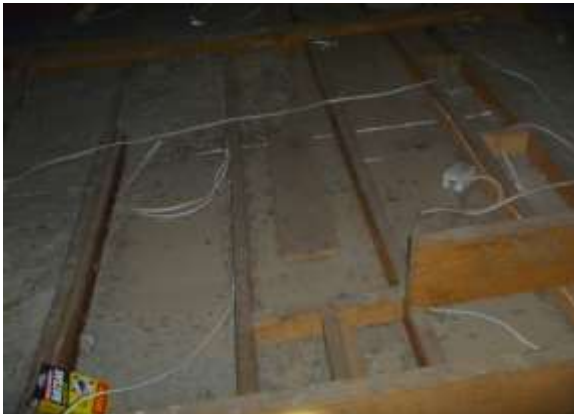
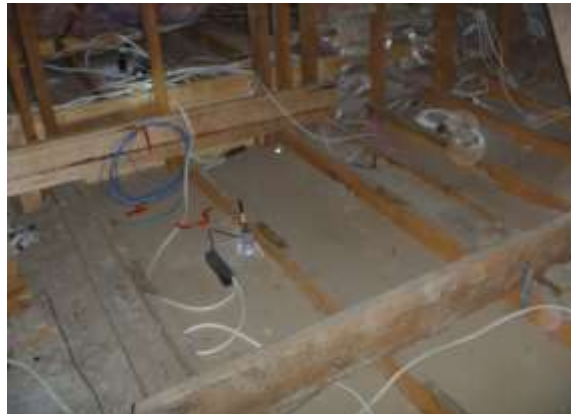
3.5.3

Information: Insulation has been moved out of place. The energy efficiency of the house may suffer due to this defect. It's recommended replacing insulation where necessary. A general contractor could be hired for this work.

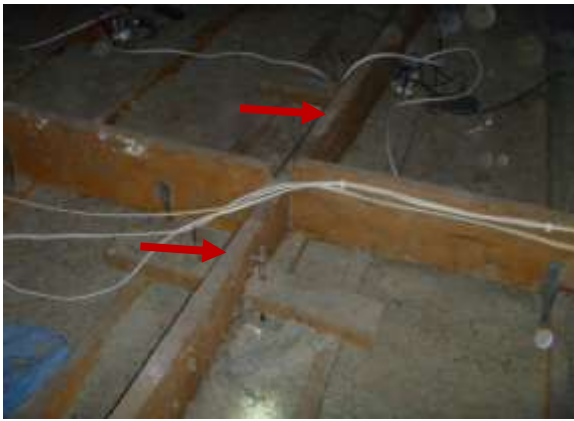
3.5.4

Information: The building element in the below picture has not been built or installed to any recognized standard. The counter beam running across the lounge appears undersized. There may have originally been a load bearing column directly under this beam at some stage, which has now been removed? Monitor the ceiling in this room and install additional support if cracking or significant deviations become evident.

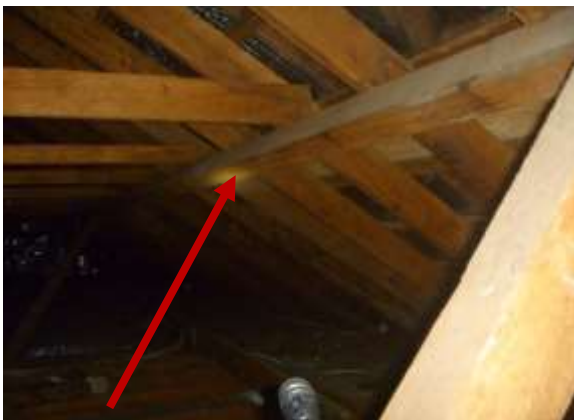
3.5.5

Information: Roof props were missing from the roof structure. It is noted that the roof was once tiled and has now been changed to lightweight metal cladding, therefore reducing the weight load. No significant deviations were observed, however any alterations to roof framing is always noted during a building inspection.

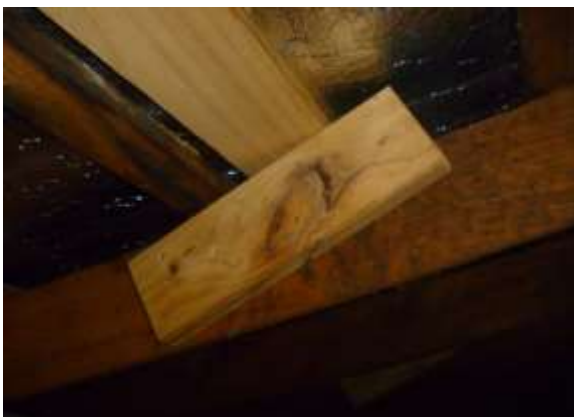
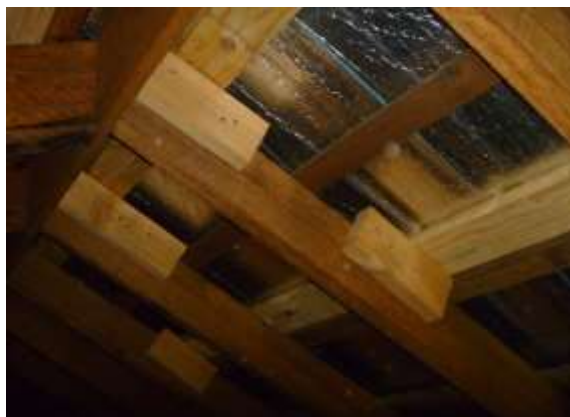
3.5.6

Information: Blocks used to pack the roof battens are considered substandard. Packing on top of the rafter is the correct way to straighten a roof unless blocks are laminated adequately. If blocks are used, they should be installed straight not on an angle, so the batten as full support. Blocks should also be screwed not nailed.

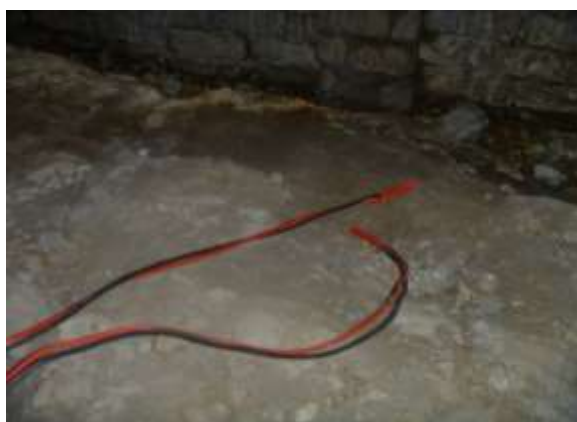
Information: Electrical cable joins are inadequate. This should have been adequately secured and boxed off to make the cables double insulated to prevent personal injury. Contact licensed electrician for repairs. Note: we are not electricians and always recommend an inspection by a professional with the appropriate licenses and qualifications.

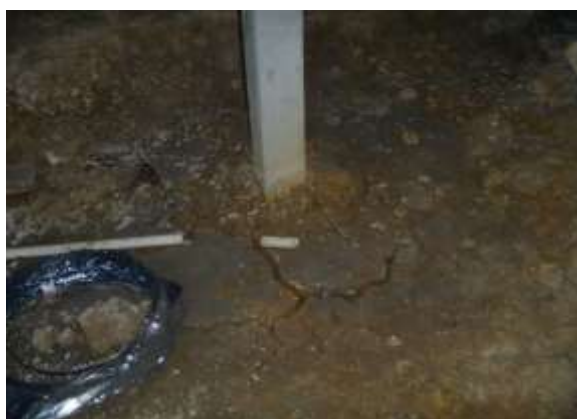
Information: The sub soil under the house was damp. Dampness was considered moderate to high and usually happens when external ground levels are higher than the subfloor area. Damp subsoil can cause damage to structural elements and help create environments conducive to termite infestation. Additional drainage in the form of an "aggie" drain will be required to eliminate lateral damp. Contact a licensed plumber or drainage specialist for further advice on this necessary work.

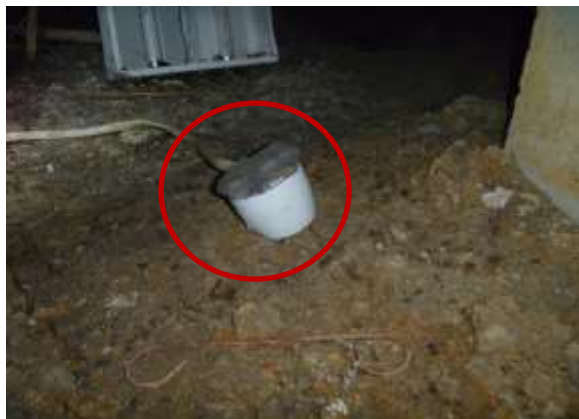
5.4.2

Information: A single power point was lying directly on moist ground. Recommended to have the point elevated and attached to the framework.

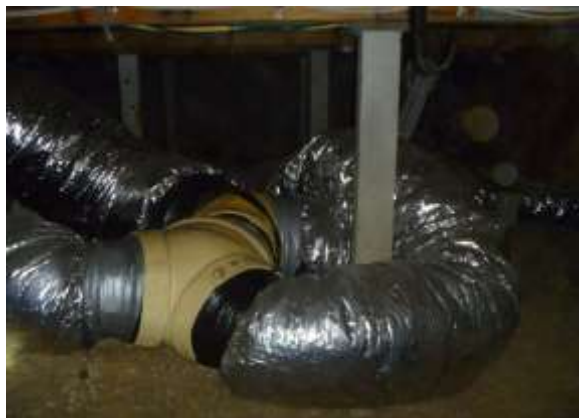
Information: Ducting has been installed directly onto the ground. Due to the moisture content in the soil, ducting will deteriorate over time. Recommended the client have the ducting elevated to eliminate the risk of future damage.

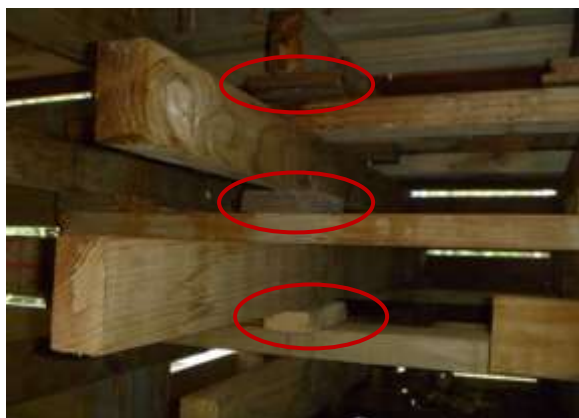
5.5.2

Information: Packing has been used to build the stairs. Stair frames like this are generally built using solid timber to reduce movement. No immediate work is required, however maintenance overtime is likely.

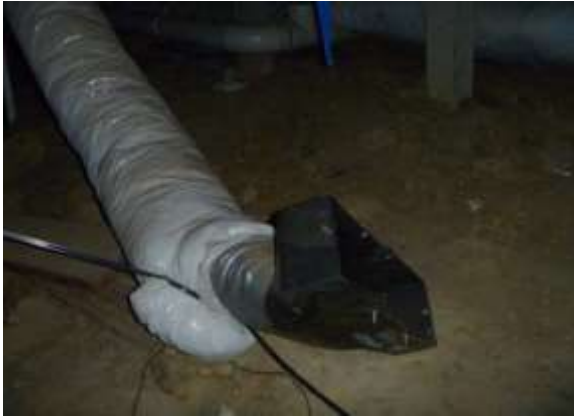
5.5.3

Information: A heating duct was not connected. Heating or cooling would be blowing directly into this space effecting the energy efficiency of the system and unnecessary costs. Contact a general contractor or heating/cooling specialist for required repairs.

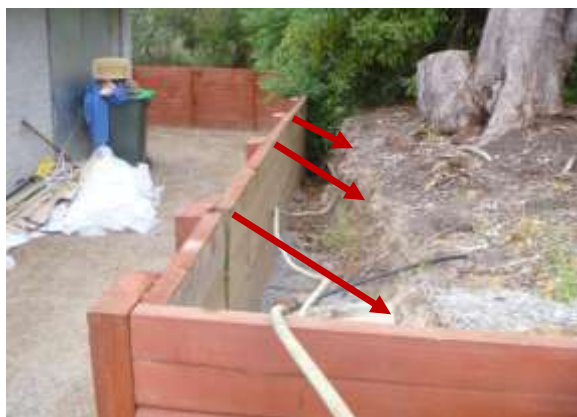
Information: Retaining walls in this area have not been completed. Drainage should be installed at the base behind the wall and then backfilled with drainage rock (i.e. scoria) Due to the height of the wall, "Deadman" supports should be installed to stop the wall moving outwards from the soil pressure, which is likely to build up overtime. A "Deadman" is where you connect the posts of the retaining wall back to a dead weight into the ground behind, usually with galvanized fencing wire. Contact a builder or landscape gardener for further advice.

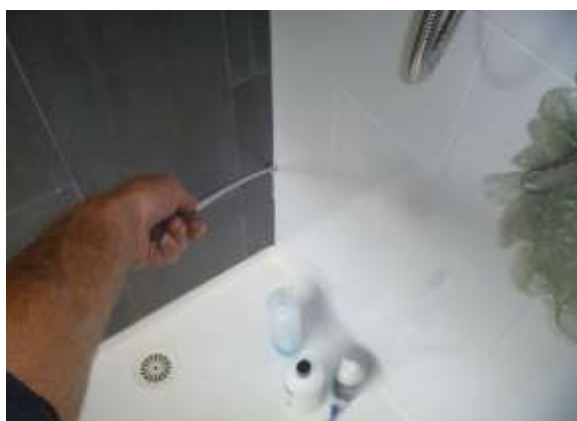
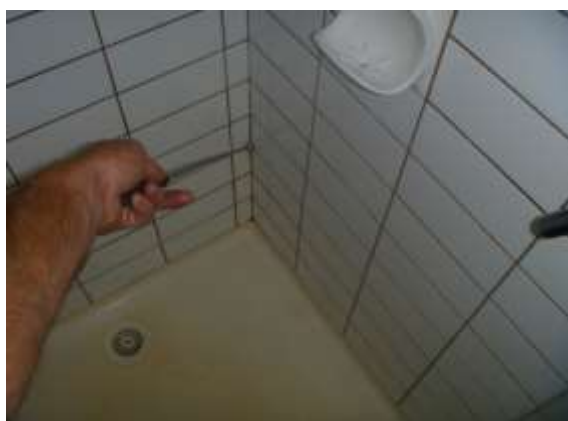
Information: It is always recommended to apply adequate sealant to the corners of showers, baths and junctions where benches meet vertical splash backs. Failure to seal these areas is likely to lead to water penetration to the underlying framework, flooring and other surrounding building elements. Consistent moisture may cause wood rot in the frame that can create hidden environments conducive to termite infestation. A general contractor could be hired to apply sealant to areas missing or damaged. See photos for example.

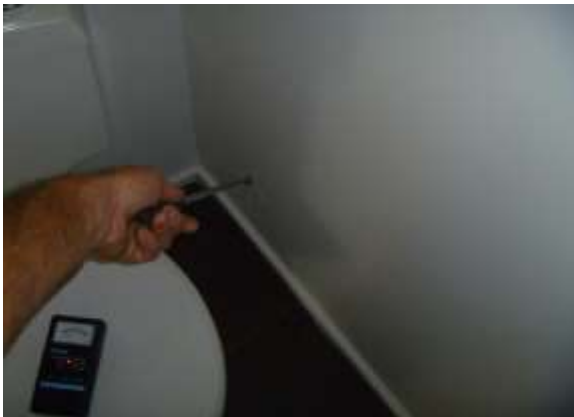
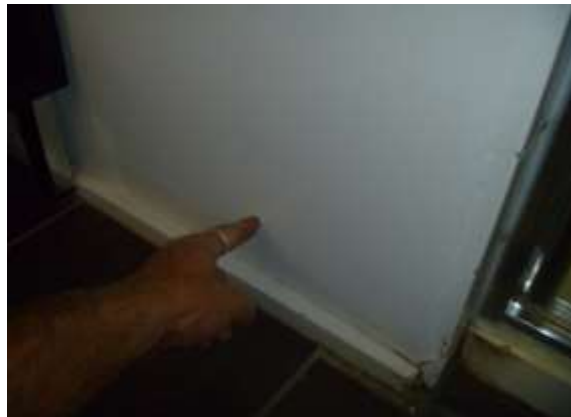
**1.6.2****Inspection Area:** Main Building**Location:** Toilet & Bathroom > Rear Left**Finding:** High Moisture Readings

Information: High moisture readings can be caused by any one of the following: conductive materials, poor ventilation, ineffective drainage, leaking pipes, leaking roofs, defective flashing or by concealed termite activity. The areas of high moisture should be investigated by way of an invasive inspection. If high moisture was reported then you must have a building expert investigate the moisture and its cause and determine what repair or treatment is required. See pictures for location.

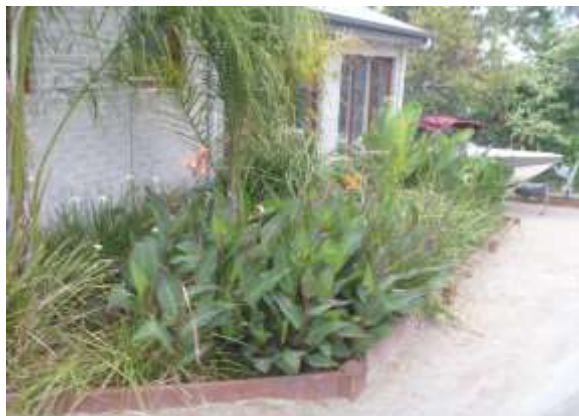
Information: Vegetation was growing close to the building exterior. It's recommended the client cut all vegetation well back from the building edges to reduce dampness to this area. These conditions are considered conducive to termite infestation and put the building at higher risk if a nest is in the vicinity of the property.

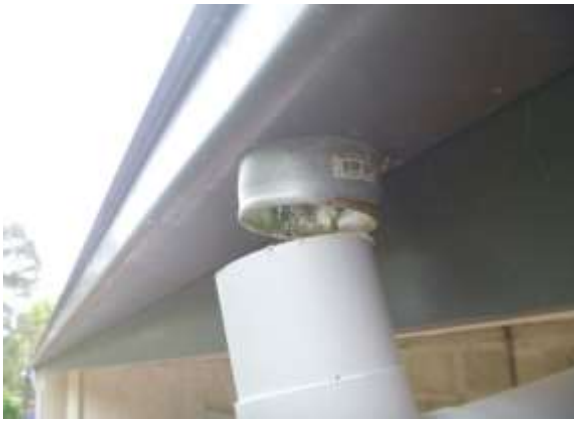
**2.6.2**

Information: The downpipes to this area was not connected to the appropriate storm water outlet. Excess water run off around the base of the building is likely, which can create an environment conducive to termite infestation if a nest is in the area. It's recommended the client contact a licensed plumber for remedial works.

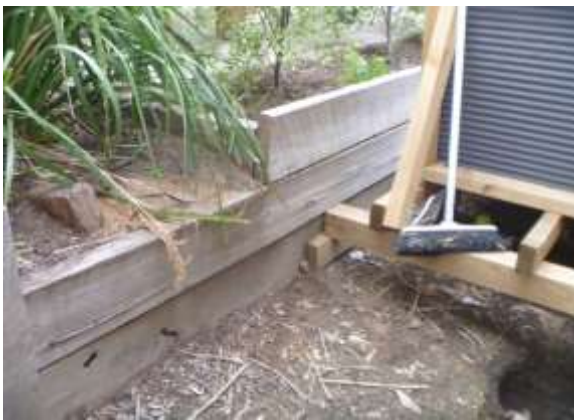
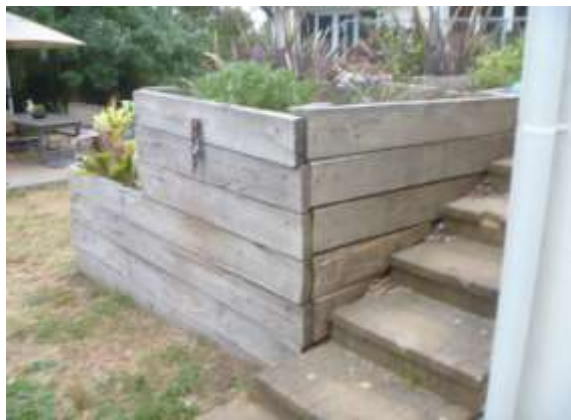
2.6.3

Information: Untreated timber was in contact with the ground. This will cause rot, which may attract termites to the area. It's recommended the client replace the timber with termite treated timber.
