PRE-PURCHASE BUILDING & TIMBER PEST REPORT

Date & Time of Inspection - 5th Oct 2014 @ : 10:30am

Address of Inspection – 15 Smith St, Smithton Hill, VIC

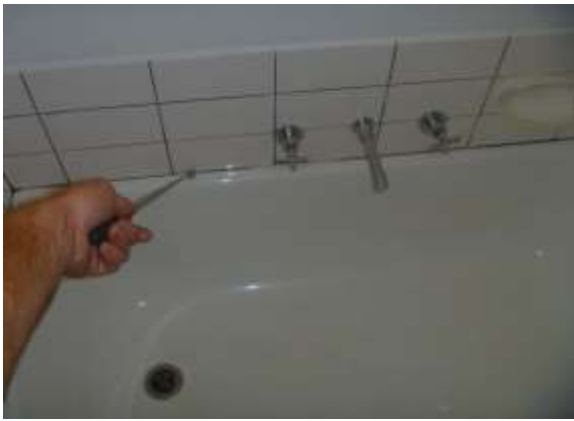
**1.6.2****Inspection Area:** Main Building**Location:** Toilet & Bathroom > Rear Left**Finding:** High Moisture Readings

Information: High moisture readings can be caused by any one of the following: conductive materials, poor ventilation, ineffective drainage, leaking pipes, leaking roofs, defective flashing or by concealed termite activity. The areas of high moisture should be investigated by way of an invasive inspection. If high moisture was reported then you must have a building expert investigate the moisture and its cause and determine what repair or treatment is required. See pictures for location.

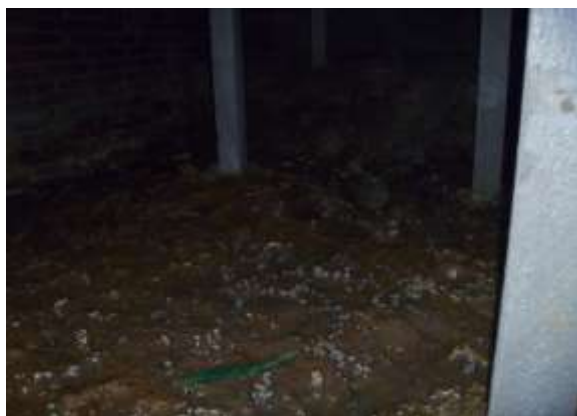
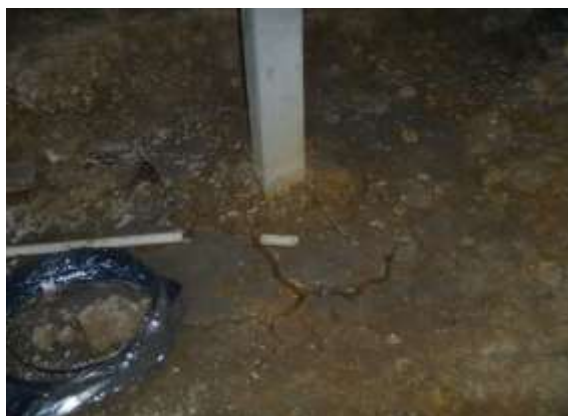
Inspection Area: Main Building
Location: Subsoil > Rear Right
Finding: Subsoil - Damp

Information: Subsoil was damp in the subfloor area. Excessive moisture in subfloor creates environments favourable for termites if a nest is within the vicinity of the building. It's recommended the client contact a licensed plumber or drainage specialist for rectification of this issue

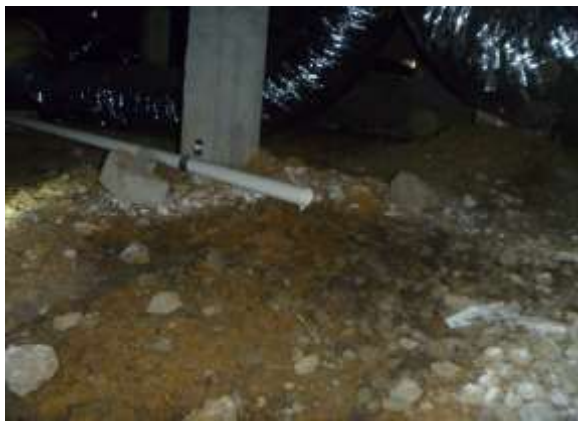
4.6.2

Inspection Area: Main Building
Location: Rear Right
Finding: AC Overflow

Information: The over flow to the AC unit runs directly onto the ground along the side of the building. Constant moisture from the overflow creates damp conditions that may attract termites to the area. It is recommended the client redirect the pipe to an appropriate drain or several metres away from the house.

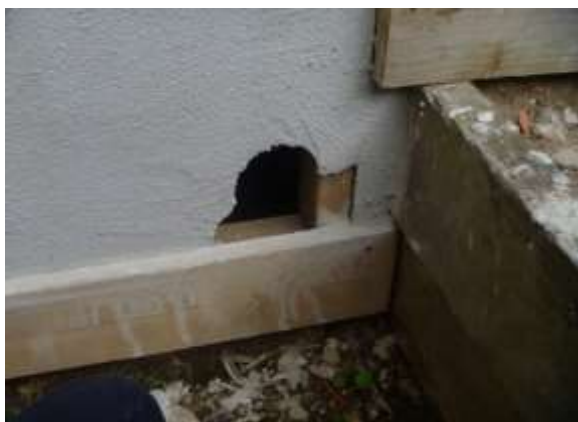
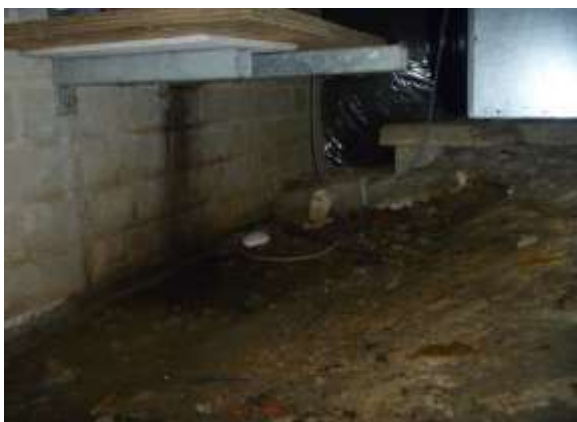
4.6.3

Inspection Area: Main Building
Location: Centre Rear
Finding: Leaking Plumbing

Information: Leaking pipes were observed under this area. Leaking plumbing can cause damage and rot to subfloor framing and flooring. Moisture from the leaks also creates an environment conducive to termite infestation. Contact a licensed plumber for repair work as soon as possible. Note: first photo is to show location of leak.

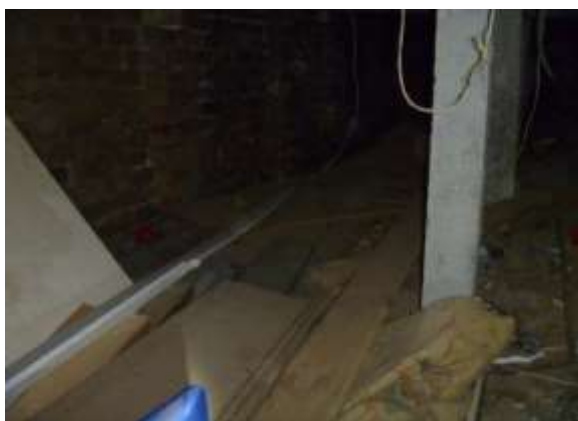
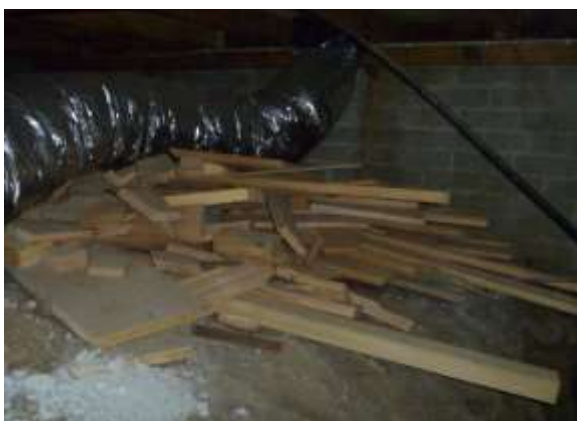
4.6.4

Inspection Area: Main Building
Location: Various Areas
Finding: Timber Off Cuts & Debris

Information: Scrap timbers and debris was found in several areas in the subfloor. While the timbers do not show any signs of termite damage, their presence creates an environment that is conducive to termite or timber pest attack, particularly if any excess moisture is found in the subfloor space. Timbers and debris should be removed to reduce the likelihood of infestation.

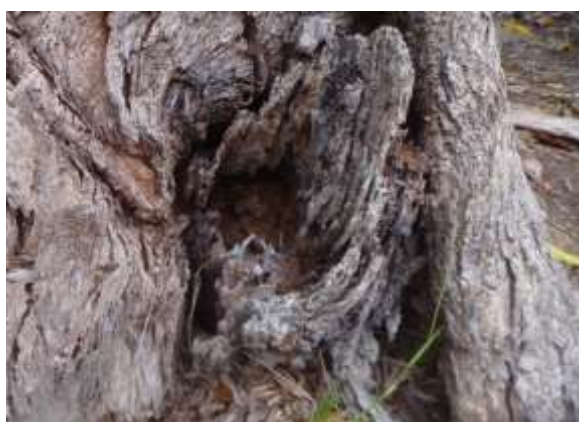
Inspection Area: Site
Location: Trees > Left
Finding: Inactive Termite Evidence - Trees

Information: Evidence of termite activity was observed in the trees in this area. This may mean a termite nest is in the tree and puts the house in a high risk category for termite attack. Contact a licensed pest control company immediately for further advice on the best treatment for the building and property and to have the tree tested for clarification on whether a nest is present or not.

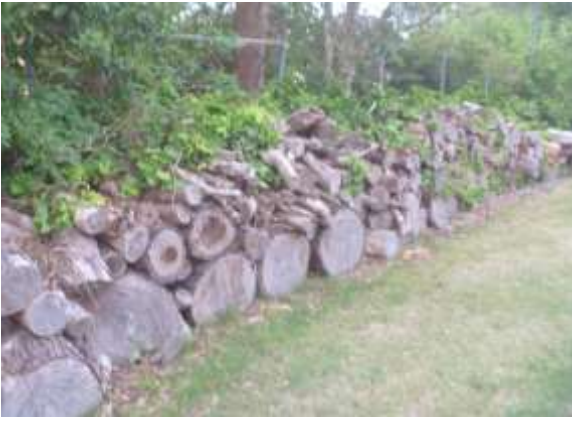
Inspection Area: Site
Location: Rear
Finding: Wood Stacks - Fungal Decay

Information: Wood stacks were located on the property and some rot was observed. Wood stacks can be a highly attractive area for termites to nest and can put the building at greater risk of termite attack due to this. It's recommended the client have the wood stacks elevated or removed completely. If removing the wood stack/s is impracticable, frequent inspections for termite evidence in these areas is essential.
